# VON KARMAN CENTER

SNAP-8 DIVISION

## SNAP-8 MATERIALS REPORT FOR JANUARY-JUNE 1965

REPORT NO. 3038 (SEMIANNUAL) / JULY 1965 / COPY NO. **13**

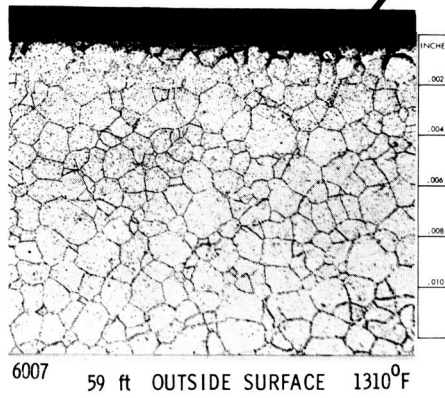
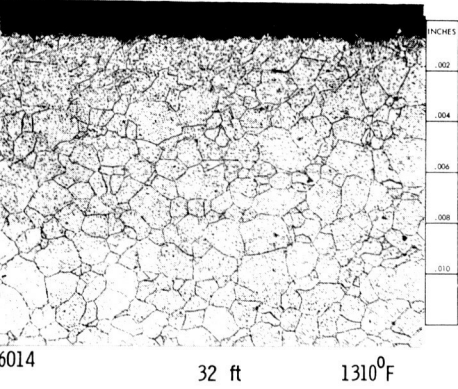
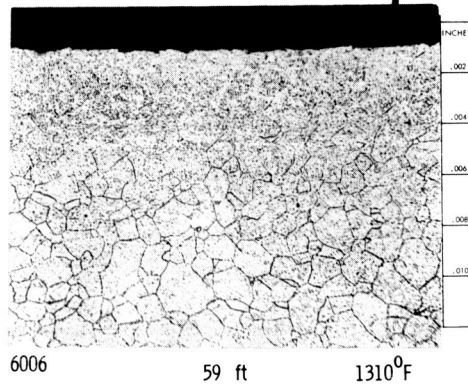
Figure 16

The 316 SS outer shell of the mercury boiler showed no evidence of corrosion. There was some carburization of the 316 SS in the hottest section (1310°F) of the boiler (Figure 16).

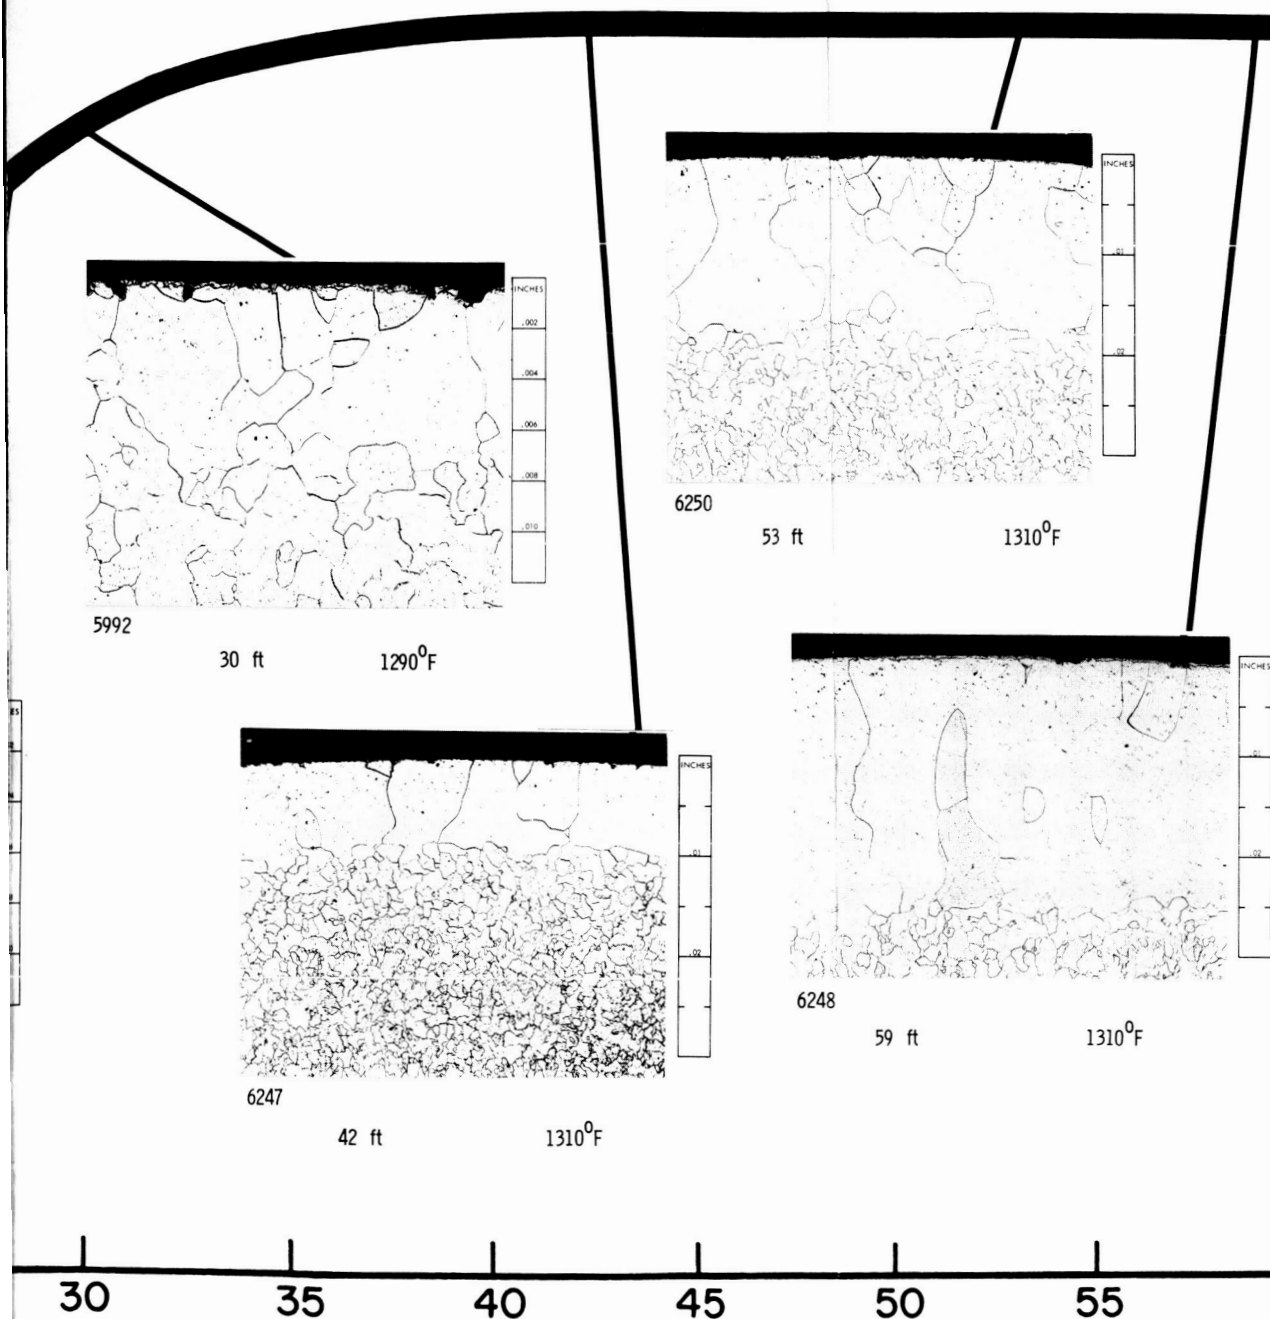
Figure 17

Some exterior cracking of the 9Cr-1Mo steel tubing was observed, primarily in the area of highest heat transfer (Figure 17), and may be associated with thermal stress or thermal fatigue. Tube cracking was also observed on the mercury side (interior) and is discussed in Section IX,A,2 below. Decarburization was found and its depth decreased gradually along the boiler toward the NaK outlet, until a point was reached where the temperature had decreased to approximately 1270°F. No decarburization was observed in tube sections where the NaK temperature was below 1270°F.

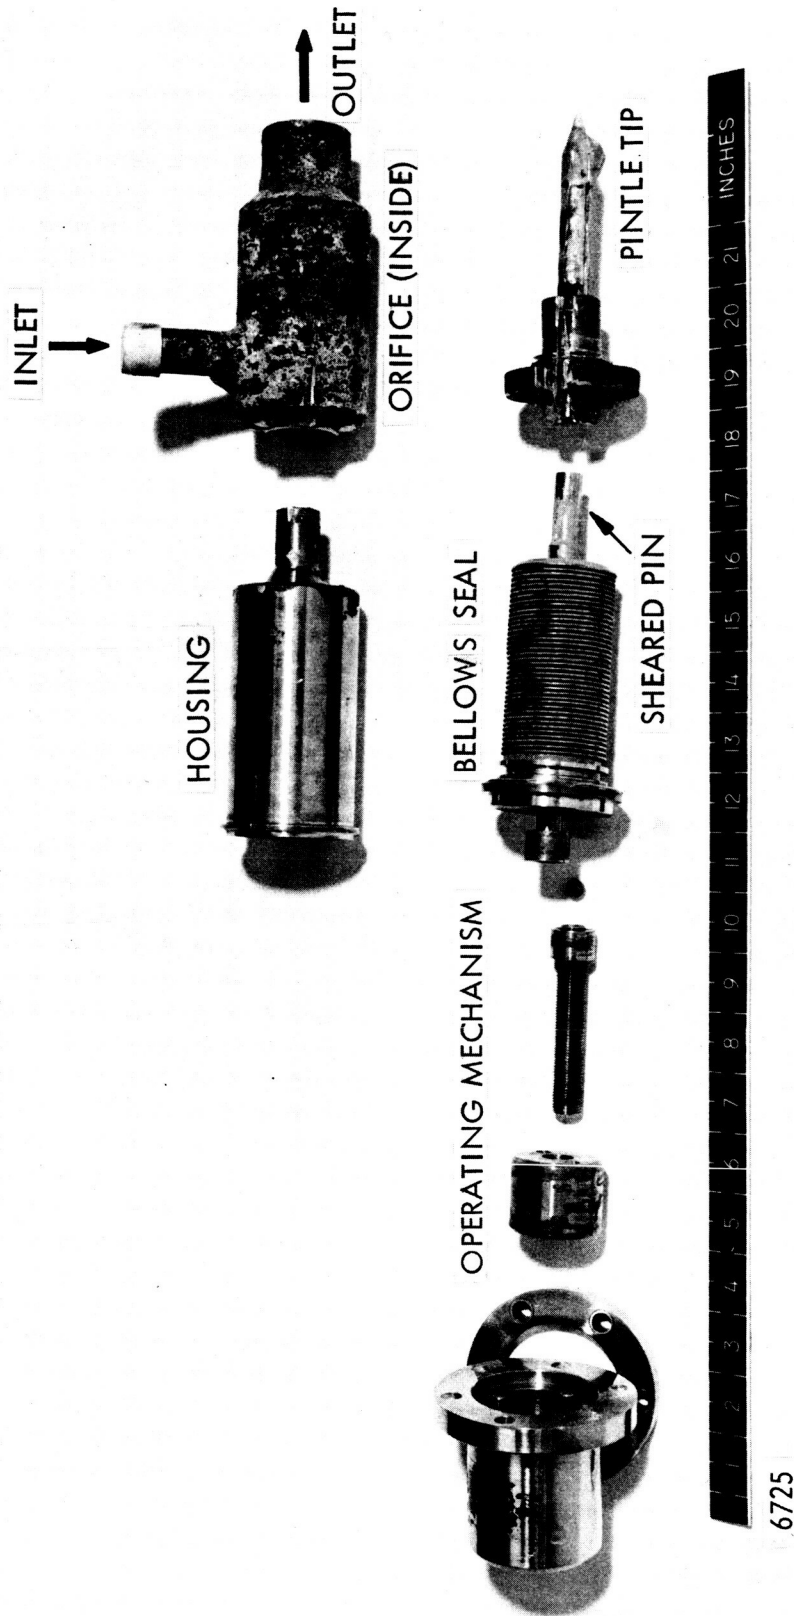
Figure 23

The adjustable choked nozzle, which could not be adjusted during the last portion of CL-3 operation, was disassembled (Figure 23) and examined visually. A sheared pin was found in its operating mechanism. The Stellite 6B nozzle and pintle tip were not eroded by the mercury vapor; there was a slight amount of corrosion-product buildup in the nozzle, and the pintle tip and nozzle were wetted by the mercury.
